Proper Copper Grounding System Stops Lightning Damage at Nebraska FM Station

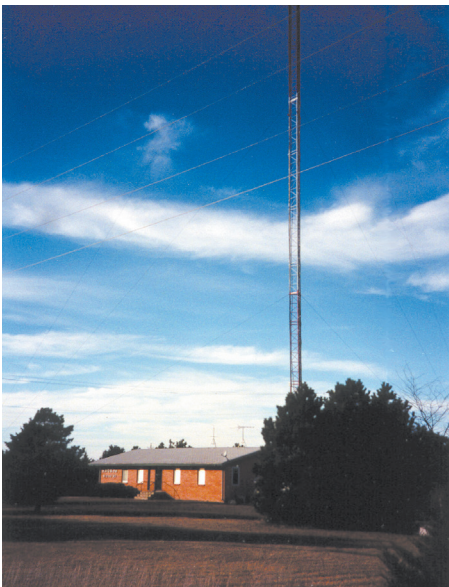
FM Station KROA, with studios, transmitter and 500-ft antenna tower in Doniphan, NE. Towers such as this are frequently struck by lightning. They must be correctly grounded to ensure personnel safety and to avoid equipment damage.

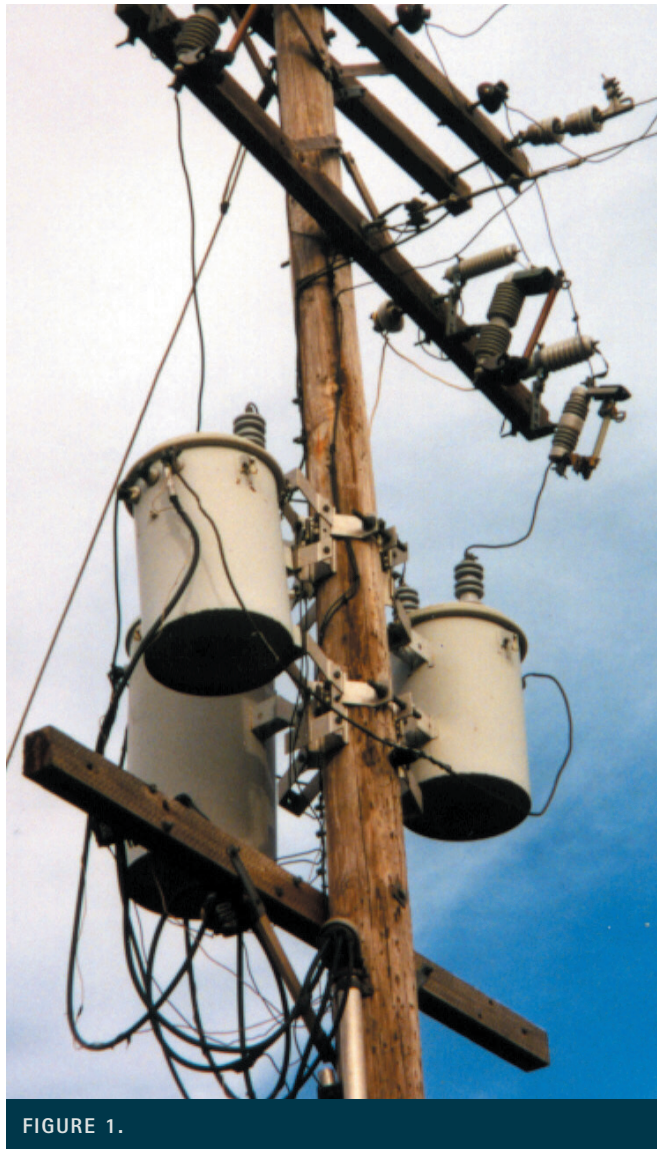
FIGURE 1.

KROA's studio-transmitter-tower complex is situated at the extremity of the local power grid. Overhead power lines terminate at a pole on the station's property (**Figure 1**). The pole is fitted with a primary lightning arrester and a conventional utility-type grounding system consisting of a #6 AWG copper down-conductor

connected to a 10-ft (3-m) copperclad electrode. When lightning strikes nearby, surge current on the utility lines should find a natural path to ground via that electrode. That doesn't always happen, however, possibly because of the electrode system's relatively high resistance to ground. As a result, voltage surges often spill over into KROA's service entrance.

Power line terminus and transformers serving KROA. The pole is grounded with a 10-ft-deep grounding electrode, but because the electrode's ground resistance is relatively high, surges due to lightning strikes on upstream power lines can pass to the station's studios, where a lower-resistance electrode provides a better path to earth. It is important that the station have good surge protection at the service entrance and that the surge protection device itself be properly grounded.

- A high-capacity transient voltage surge suppressor (TVSS) was installed at the main electrical panel, thus providing better protection against voltage spikes from the utility grid. Conroy specified a surge suppressor suitable for the center-tapped delta configuration. He maintains that "A TVSS is about the cheapest lightning insurance you can buy. TVSS devices are available in a broad range of sizes and types, they don't cost much, and they're easy to install. But, they require a good grounding system to work properly."

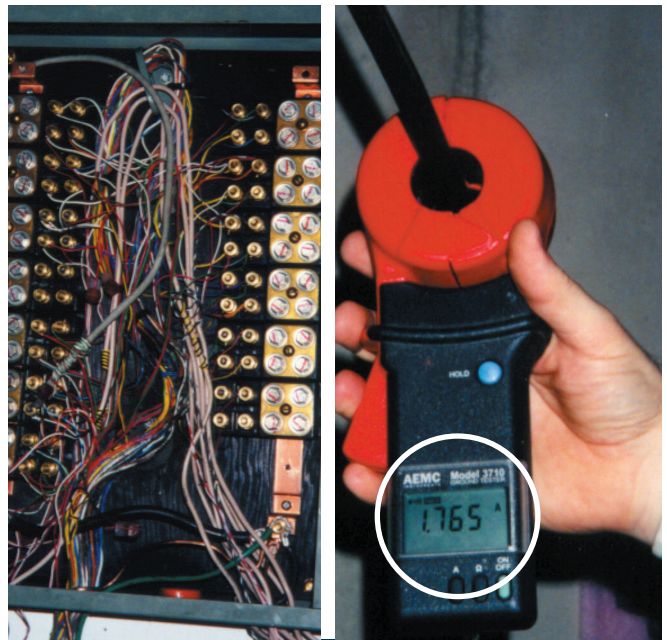
FIGURE 2.

An inadvertent neutral-to-ground connection in an equipment panel (left photo, lower left) caused a ground loop current of more than 1.7 A to flow in KROA's grounding circuit (right). This current generated a white background noise in the station's audio signal.

- An inadvertent neutral-to-ground connection in a sub-panel allowed neutral current to circulate in the ground system (**Figure 2**). This circulating current, which was rich in RF, probably caused the white noise heard in the station's audio signal and telephone lines.

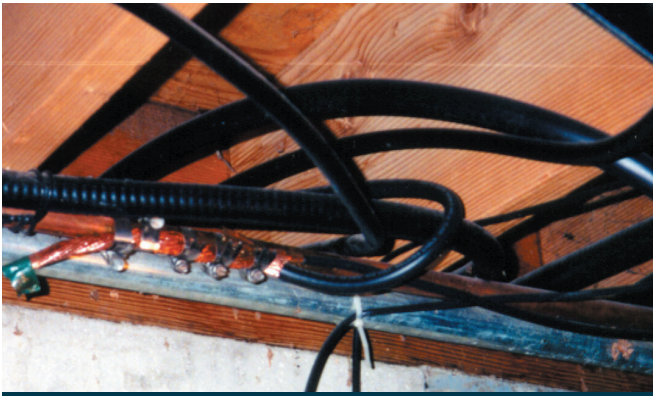
FIGURE 3.

Portion of an interior grounding bus, constructed from copper plumbing tube and installed in station KROA's transmitter room. Several equipment ground conductors were connected to the copper tube with hose clamps (center of photo). High-impedance grounding connections such as these detracted from optimum station signal quality.

- A form of halo ground had been constructed inside the transmitter room using lengths of copper water tube to which various pieces of equipment were connected (**Figure 3**). The innovative halo provided a convenient ground bus, although connections to it could not be made with low-impedance grounding lugs. This factor may have contributed to the station's sub-optimum signal-to-noise ratio.

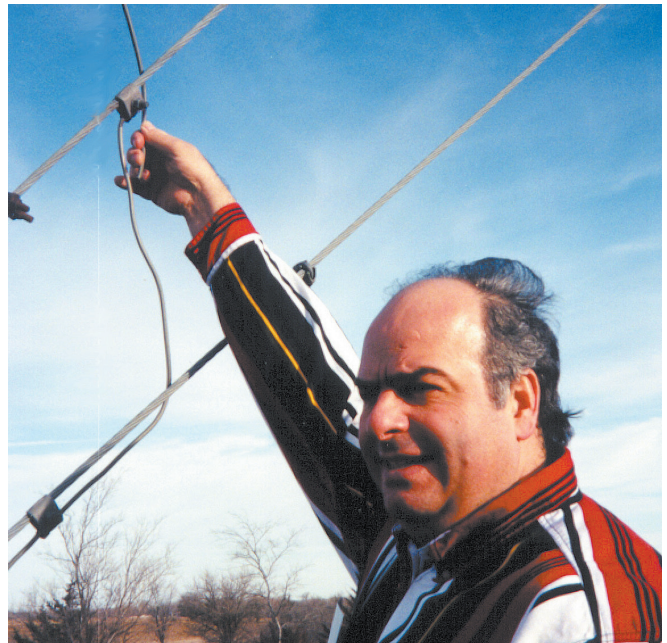
FIGURE 4.

- Based on a belief that "too much" grounding was attracting lightning strikes, grounding connections on the tower's six sets of guy wires had been disconnected sometime in the past (**Figure 4**). This action may, in fact, have helped direct lightning discharge current down the antenna tower itself, bringing the strike closer to the studio/transmitter building.

KROA station engineer Wayne Nestor shows disconnected grounding conductors at one of the station antenna tower's six sets of guy wires. The conductors had been disconnected in the mistaken belief that "too much" grounding caused the tower to attract lightning. The scheme was ineffective, and it may have contributed to one lightning strike's entering the station's broadcast studio, destroying expensive equipment. New grounding conductors, plus new low-resistance grounding electrodes and a web of 250-kcmil grounding electrode conductors, have prevented any subsequent lightning damage to the station and its equipment.

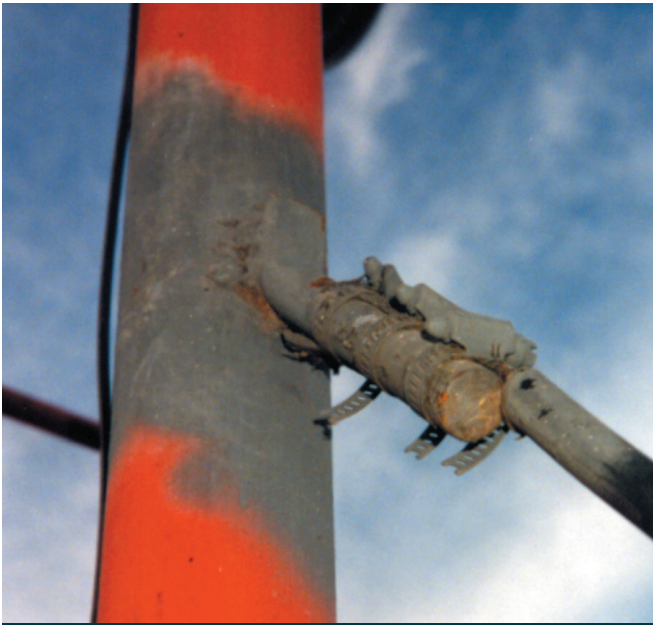
FIGURE 5.

- Conroy found that the tower and its grounding conductors were connected to three 10-ft deep grounding electrodes located about 10 feet from the tower in a roughly triangular pattern. In principle, this is a sound practice. However, the electrodes required upgrading to reduce their resistance to levels appropriate to the station's equipment. Conroy also found that the system's three solid #6 AWG grounding electrode conductors were connected to the tower base using steel clamps, which had corroded, further increasing the resistance to ground (**Figure 5**).

Grounding electrode conductor connected to the KROA antenna tower using steel clamps. Corrosion, which can be seen staining a layer of gray rust-proofing paint, contributed to resistance levels greater than the maximum values noted in IEEE 142, IEEE 1100, TIA/EIA 607 and other recommended practices. These improvised connectors were replaced by corrosion-resistant copper alloy lugs.

- Three 50-ft grounding electrodes were driven in a triangular pattern surrounding the antenna tower. Ground resistance at all of the deep electrodes consistently measured less than 3 ohms. The electrodes were connected with the tower using special welded grounding taps. Down-conductors from the antennas were rewired in 250-kcmil copper. These were bonded to the electrodes using bronze

connectors. All three electrodes were interconnected to form a ring ground surrounding the tower. The ring was then connected to the station's principal grounding electrode, again using 250-kcmil copper. The entire grounding system now exhibited a uniform and low (<3 ohm) ground resistance.

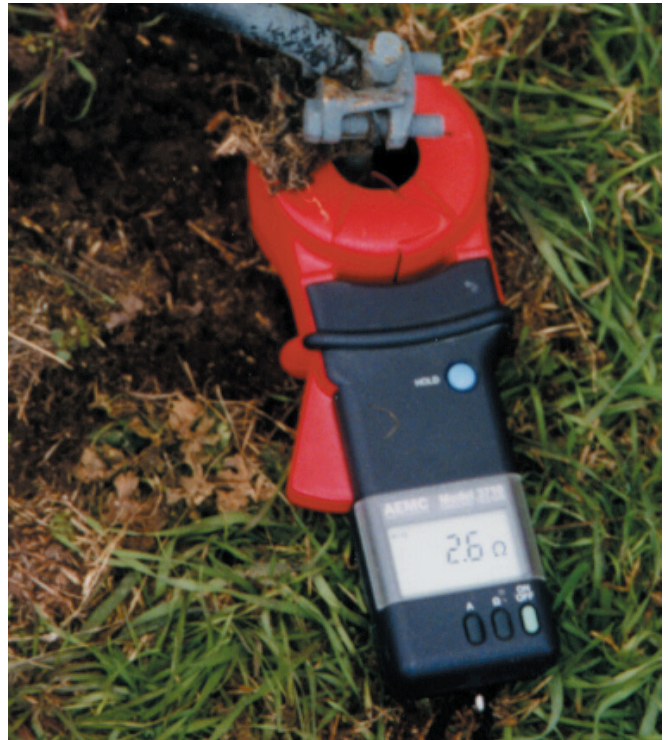
FIGURE 6.

A new 40-ft deep copper-clad grounding electrode installed at station KROA by Computer Power & Consulting indicated a ground resistance of only 2.6 ohms, well within recommended limits. A copper-alloy clamp connects the electrode with the stranded 250-kcmil grounding conductor. Connectors of this size surround the tower in a ring ground.

- A 40-ft deep copper-clad grounding electrode was driven near the main service entrance. Heavy gage (250-kcmil) stranded copper grounding conductor was used to connect the electrode with the ground bus linking the transformer and the main electrical panel. All connections were made with corrosion-resistant bronze connectors (Figure 6).
